PAINT ANALYSIS

TREATMENT

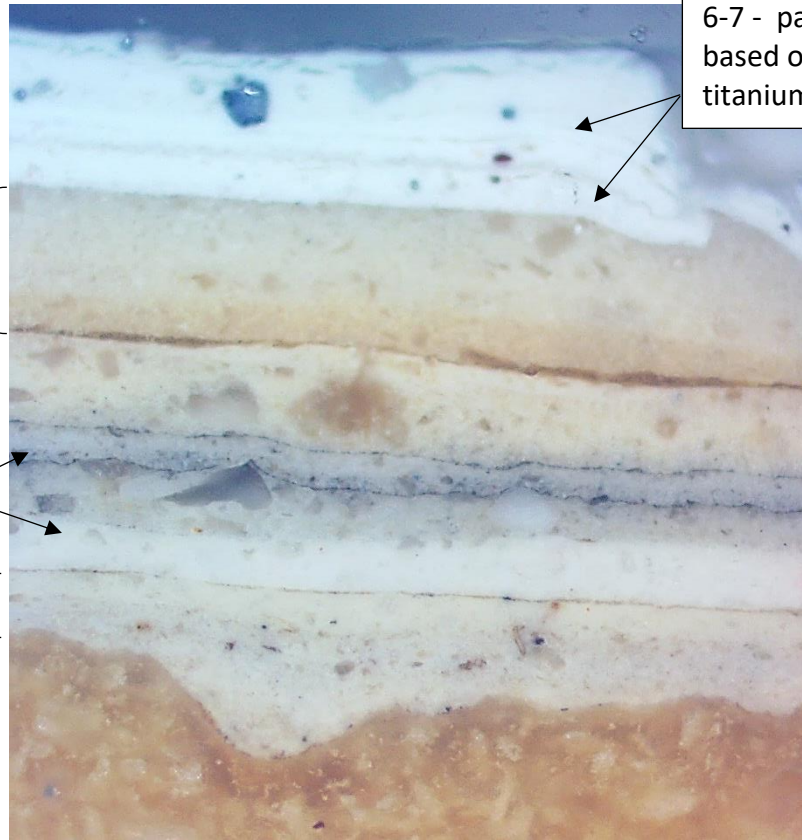
SAMPLE 1
Left leg

The statue has been painted seven times. The layers were best preserved in Sample 1. Sample 2 appears to have come from an area that has suffered damage in the past.

- 5 – last lead paint
- 4 – buff paint with thin coat of varnish
- 2-3 – two grey schemes
- 1 - original paint

6-7 - paints based on titanium white

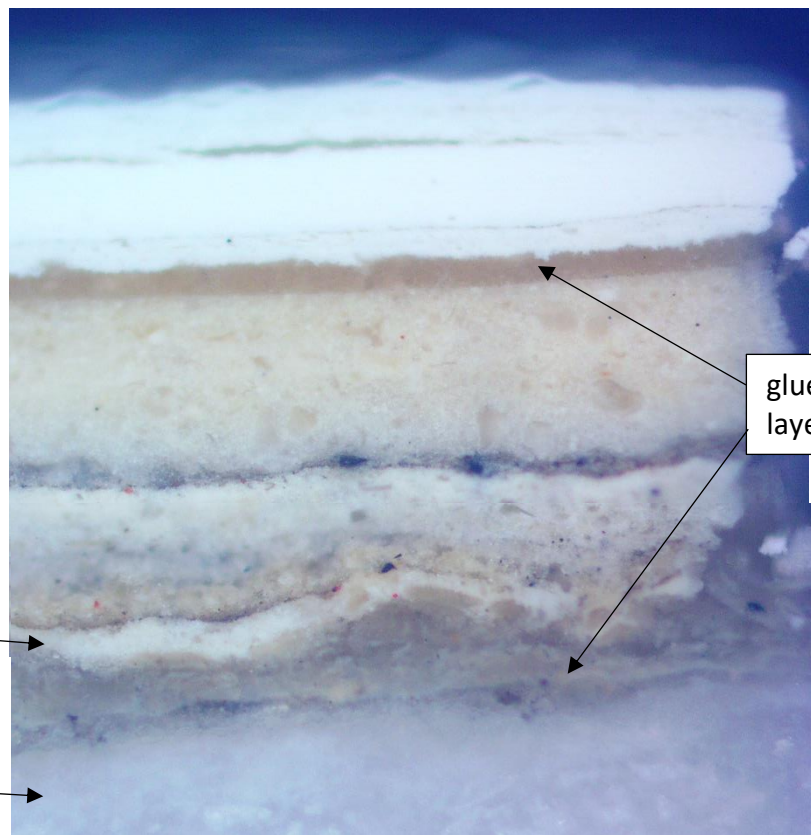
SAMPLE 2
Left back

Some layers missing, and a coat of what appears to be glue has worked its way down under the early paints

- flake of original paint
- plaster

glue layer

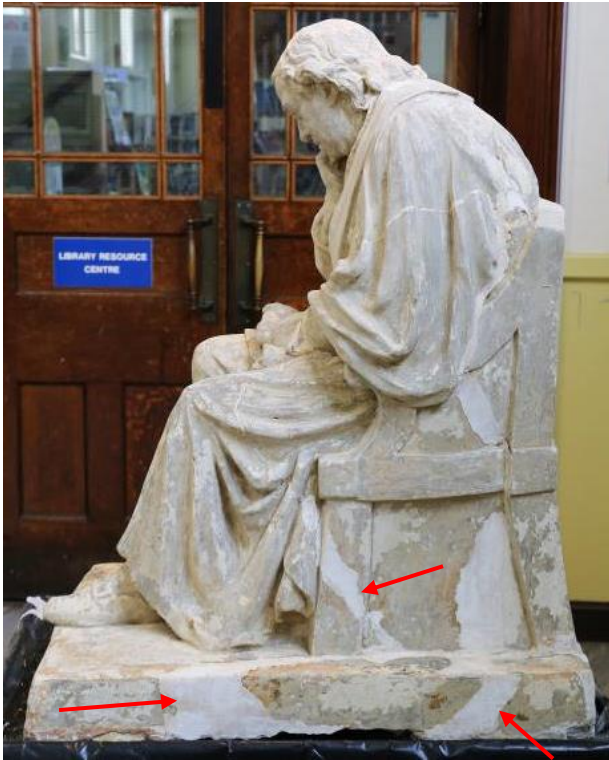
- Large areas of fills were revealed
 - The fillers used to fill those areas were used too excessively and overlapped many areas of undamaged original plaster surface

- They also overlapped 5 layers of paint that the sculpture was painted in before this restoration intervention was undertaken; as a result, all the fills were protruding (once all the paint layers were removed from the surface)

Fills overlapping original plaster surface (examples showed with red arrows)

- All fills had to be remodeled and aligned with the original plaster surface
- Areas, where the fills were applied excessively and overlapped the original plaster surface, had to be treated too; all excess material of old fills had to be removed and (as with the other old fills) the remaining fills had to be adjusted to make them flush with the surrounding plaster surface

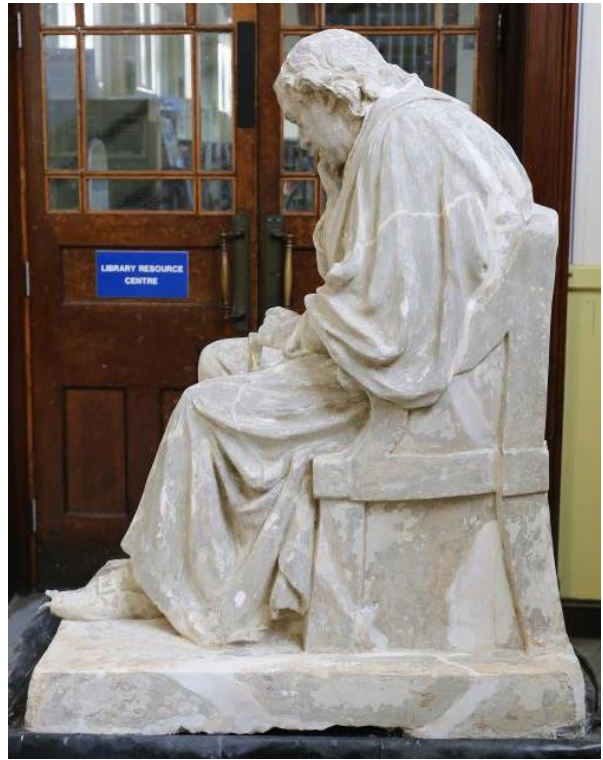
Adjusting old fills and re-filling

- In many areas plaster substrate was missing or damaged; new fills were required in those areas; they varied in size; Plaster of Paris was used as the most appropriate filler

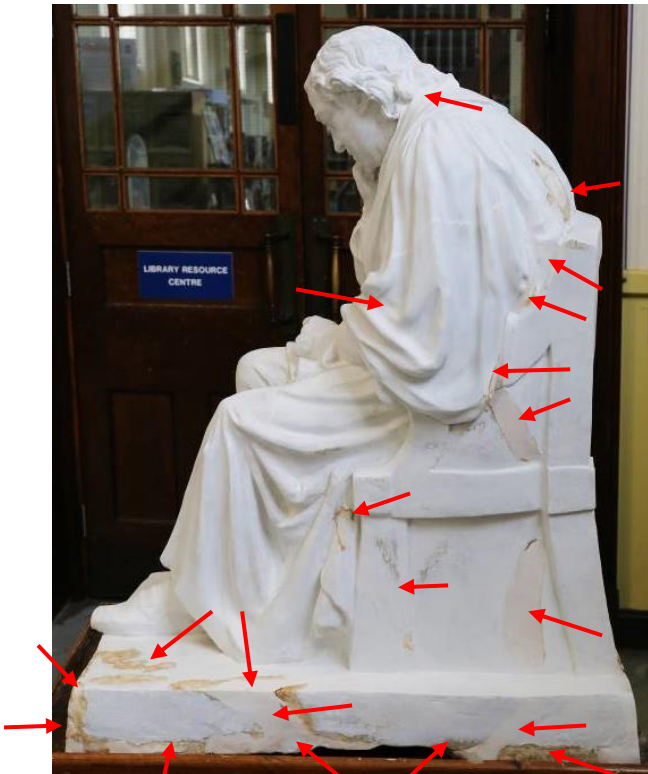
- The paint dried fully on about 90% of the surface but in remaining 10% of the surface the paint remained wet and tacky; the following was observed:
 - The paint was not drying in areas where it was covering old fills that were used during the 20th century restoration

- The paint was also not drying in some other areas for no apparent reason; these areas were exactly the same as the surrounding surface; these were mainly on the base and none of the old paint was present in these areas; some of these areas (that were not drying) look like 'splashes' and 'brushstrokes' in shape but visually, there were the same as the surrounding surface

Problematic areas (paint not drying in these areas; the new paint had to be removed and areas treated; red arrows show examples)

- As neutralizing delivered some success, different concentrations were tested; as this delivered more positive results in some areas, the process of neutralization was repeated several times; gradually, there were fewer and fewer problematic areas; the process was repeated until all areas were treated successfully and they were no longer reacting with the new paint

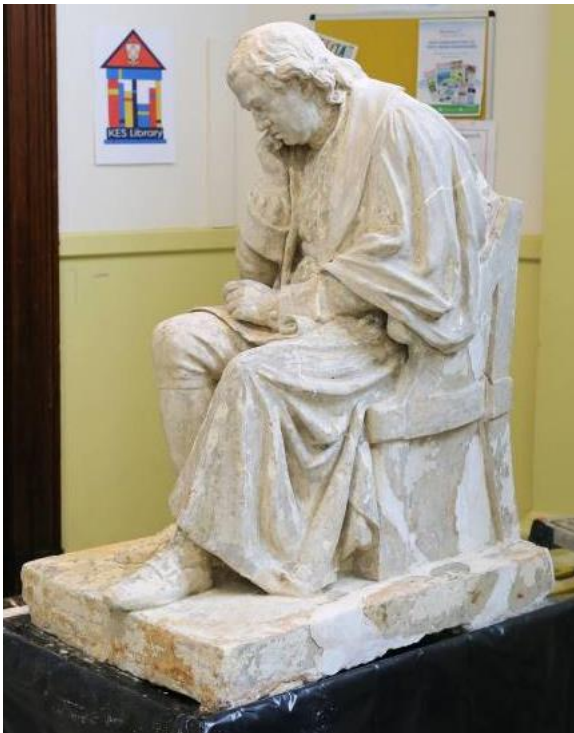
- Extensive old restoration treatments were revealed during the paint removal as it became apparent that the sculpture was partially broken in the past and consequently repaired

During treatment – paint removal,
extensive old restoration;
old fills – excessive

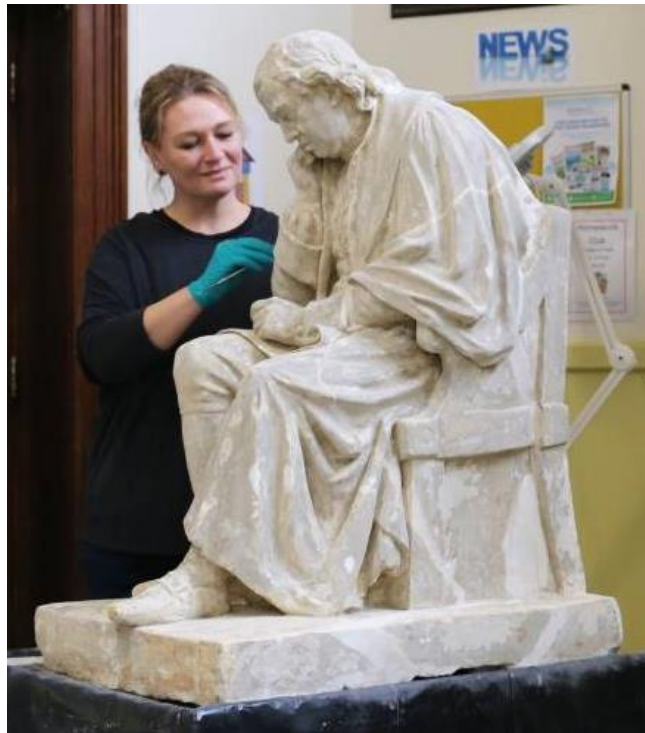
During treatment – adjusting fills

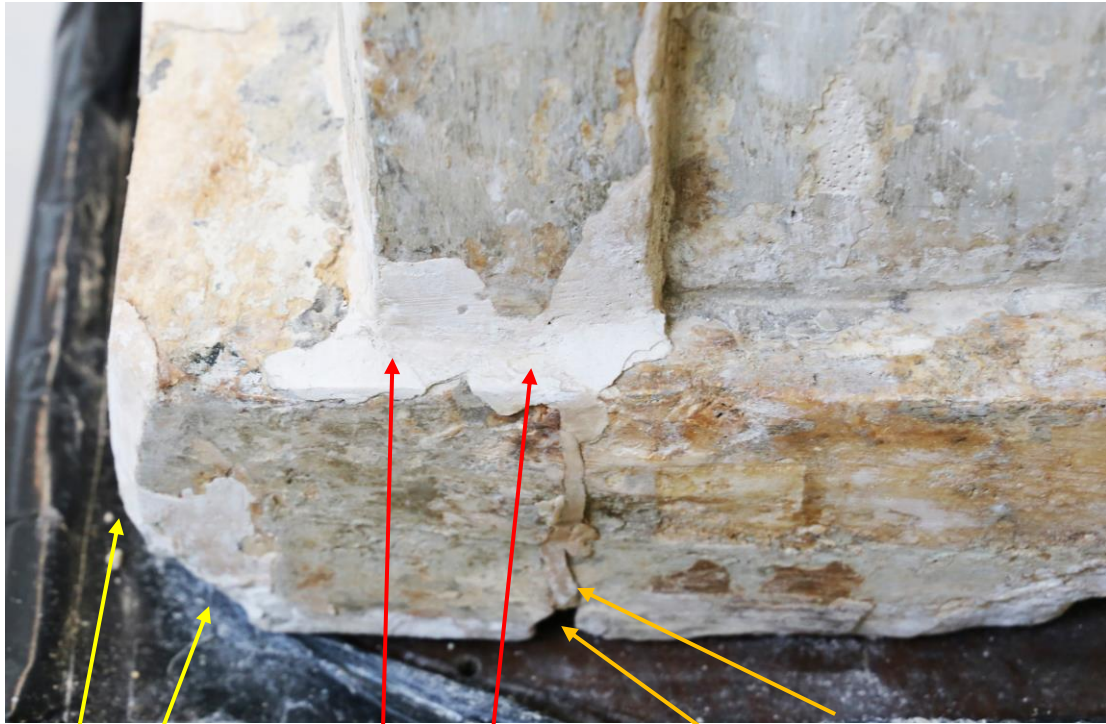
Missing plaster substrate

excessive amount of old fill overlapping original plaster

old fill is loose & partially missing

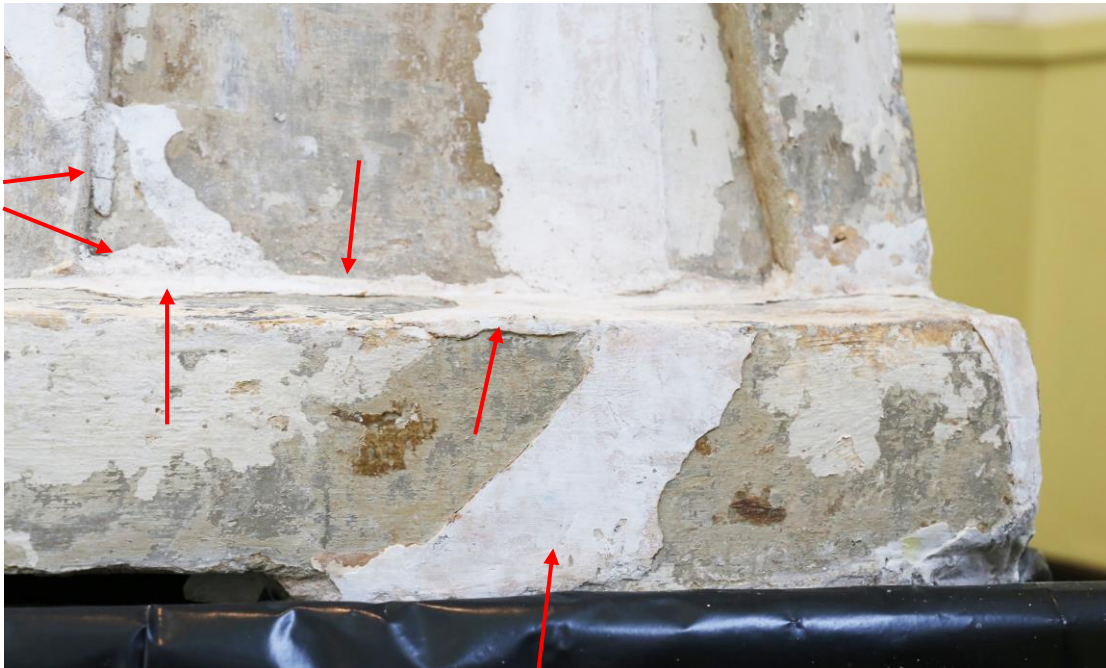
During treatment: examples of old fills that are 50% bigger (width-wise) than they are supposed to be

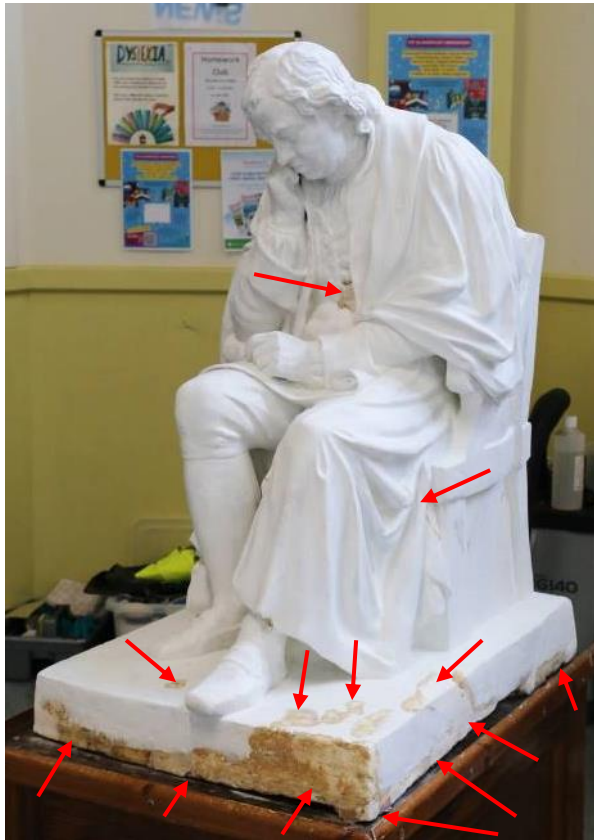
plaster substrate itself in those problematic areas; it appeared that those areas were saturated with something in the past (most likely during the past restorations) and that substance remained within the highly porous plaster substrate; furthermore, when the images of S Johnson (undertaken before the commencement of the conservation treatment) were carefully examined, it showed that the old paint layers in those problematic areas were 'damaged'

Persistent problematic areas (paint not drying); remedial treatment had to be repeated several times in these areas to resolve the problem

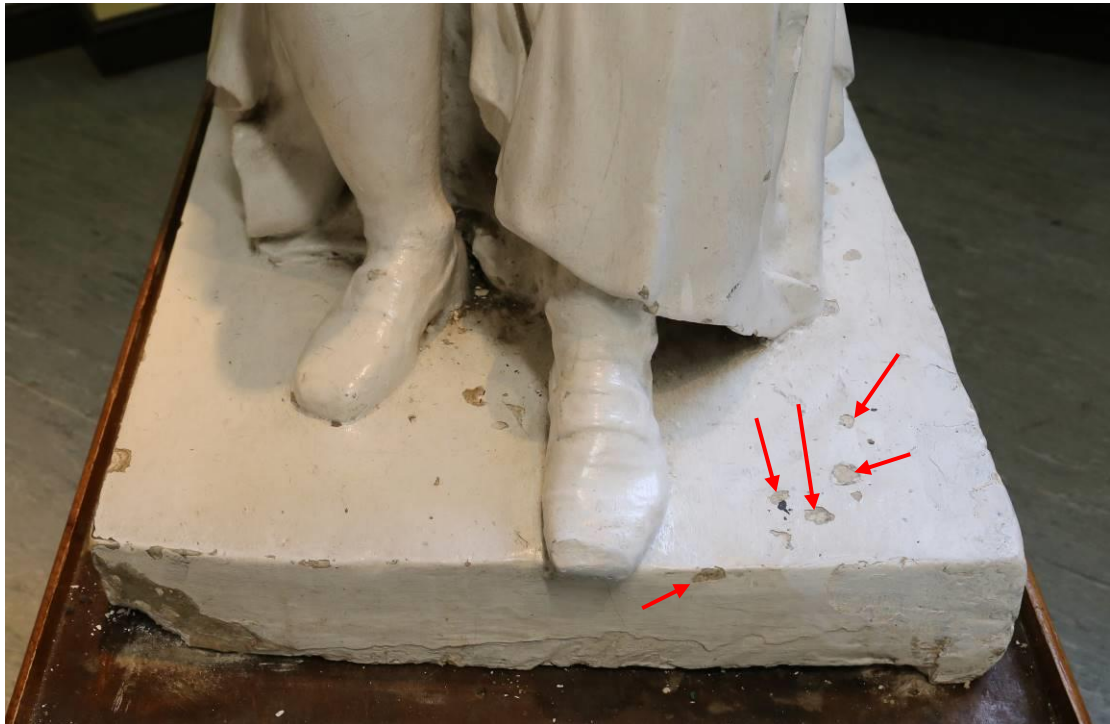
Before treatment (red arrows show examples of problematic areas where the new paint was not drying after the old paint layers were removed)

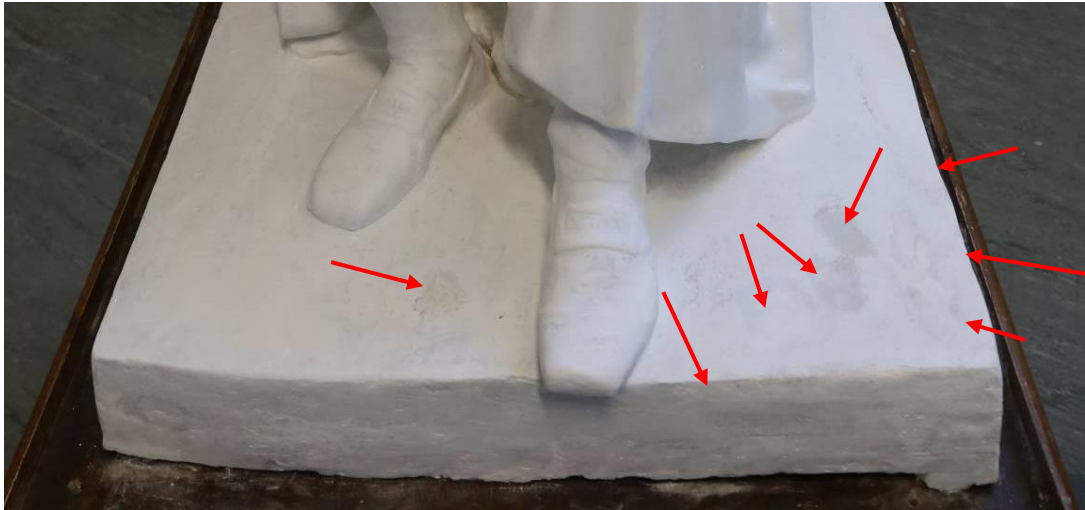
During treatment - examples of areas where the new paint was not drying (new paint still on)

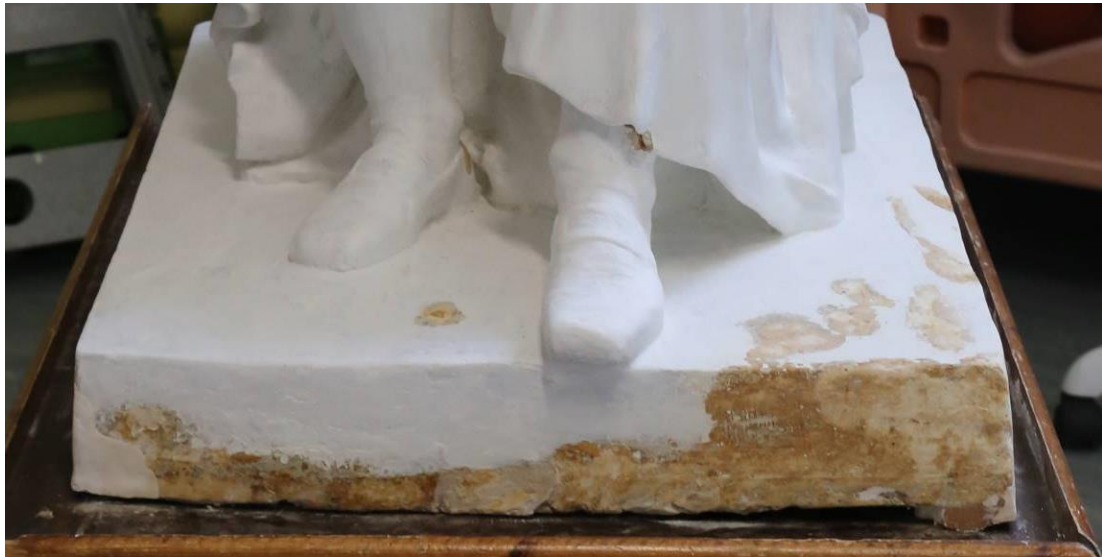
During treatment – the new paint had to be removed from all areas where it was not drying; this process had to be repeated until the problem was resolved; each section behaved differently; some needed just one intervention but in other areas they had to be treated (neutralised) several times
